Armstrong Track Consultants

Wairoa to Gisborne---Track Review

Between 22nd and 25th of July 2019 an inspection/review was undertaken between the 296.3km (Kiwi Road Wairoa) and 391.6km (Gisborne Port). This exercise was conducted in hirail vehicles and was demanding because of the restricted access due to slips, vegetation and 5 significant drop outs which have severed the line.

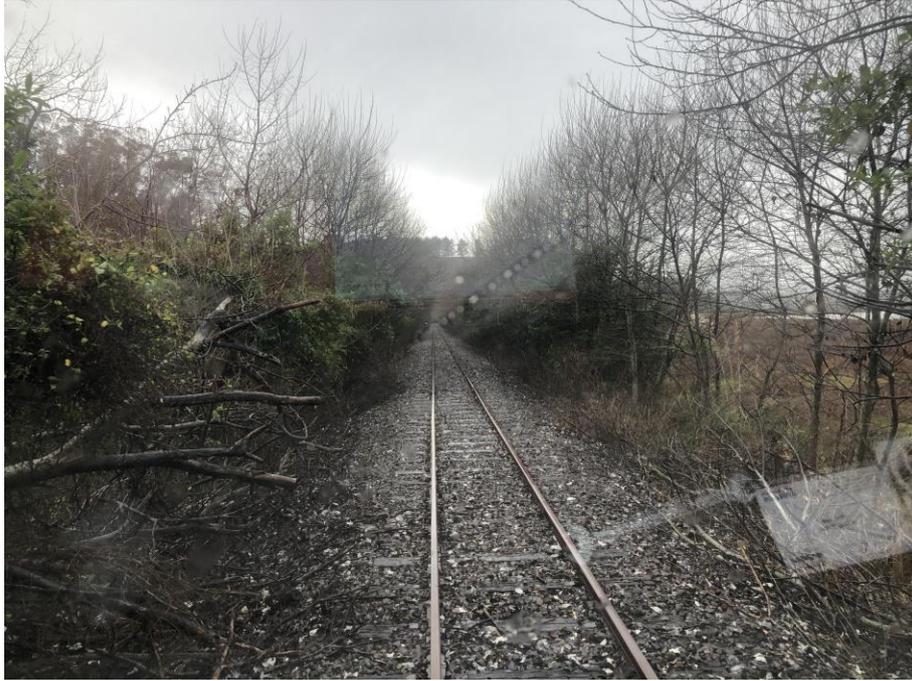
Figure 1, larger trees to cut back

A mechanized scrub cutting exercise is required over virtually the entire 77kms of unused track. This would normally be a hirail excavator with a mulching head or saw blade. This machine would require additional support from a bushman with a chainsaw for larger leaning trees and branches. Treescape Ltd is the preferred supplier for KiwiRail and carried out a similar exercise on the Napier to Wairoa section

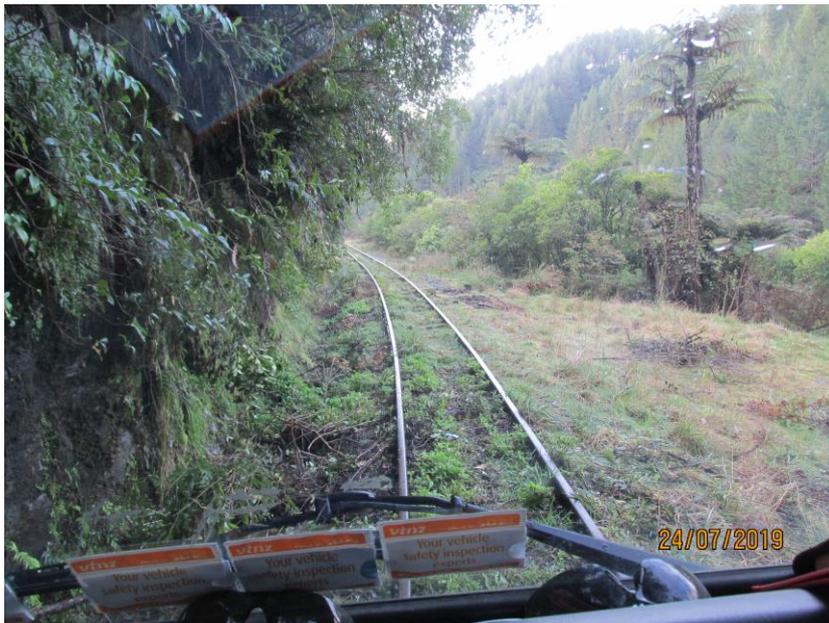
Figure 2, Scrub encroachment

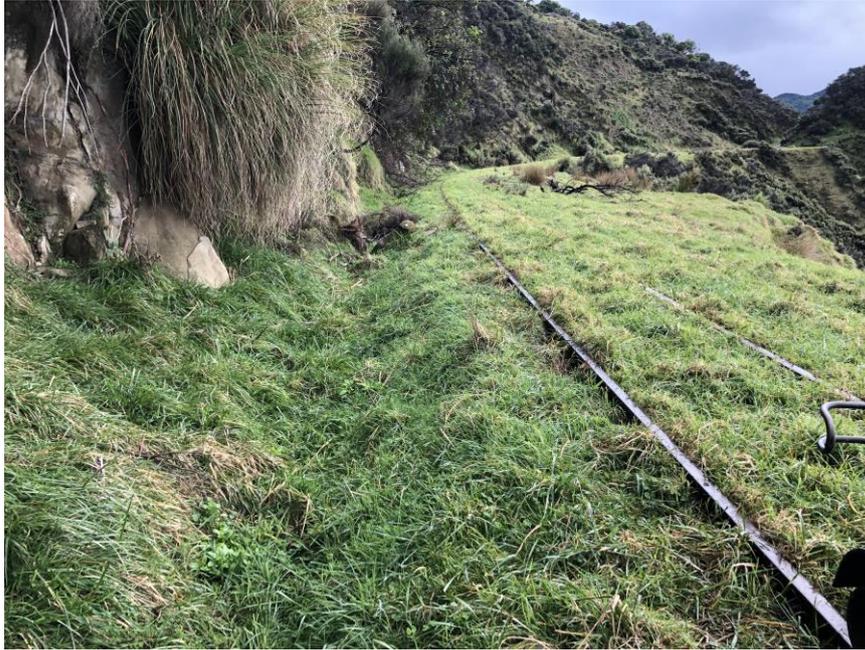
For large section of the unused track there has been mud flows, and grass type vegetation growing on top of the sleepers. In several locations

in the central part of this track (329 to 358km) only the top of rail is exposed. See the photos below.

Figure 3 Track vegetation

A highrail machine needs to be engaged with a simple plough to traverse through the section treating all sites to expose top of sleeper and fastenings (to a degree). The same type of plough can be used on a small front end loader but the number of bridges which are likely to be encountered precludes efficient usage.

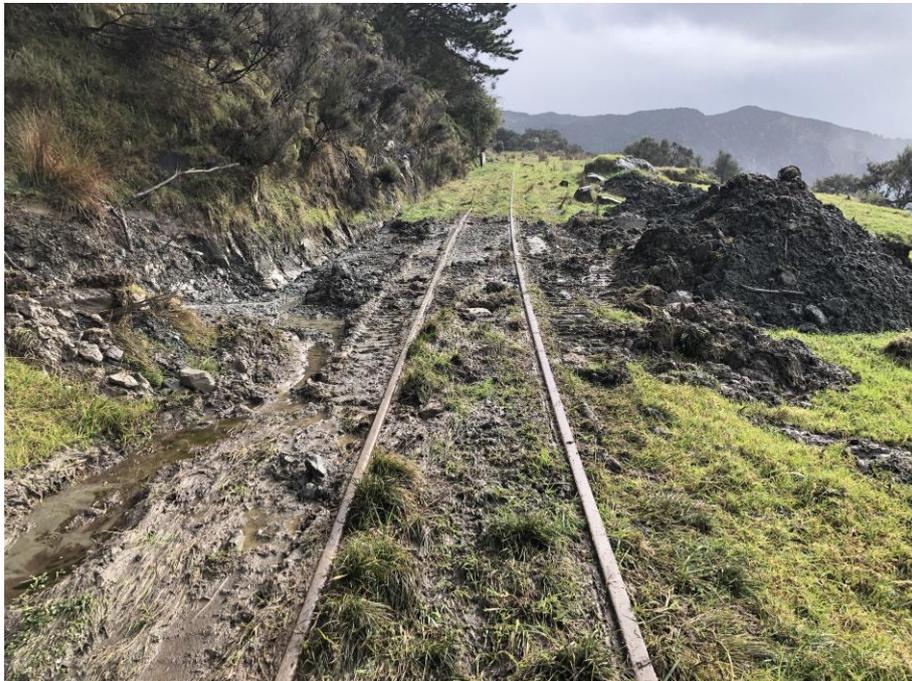
Figure 4 Slip material

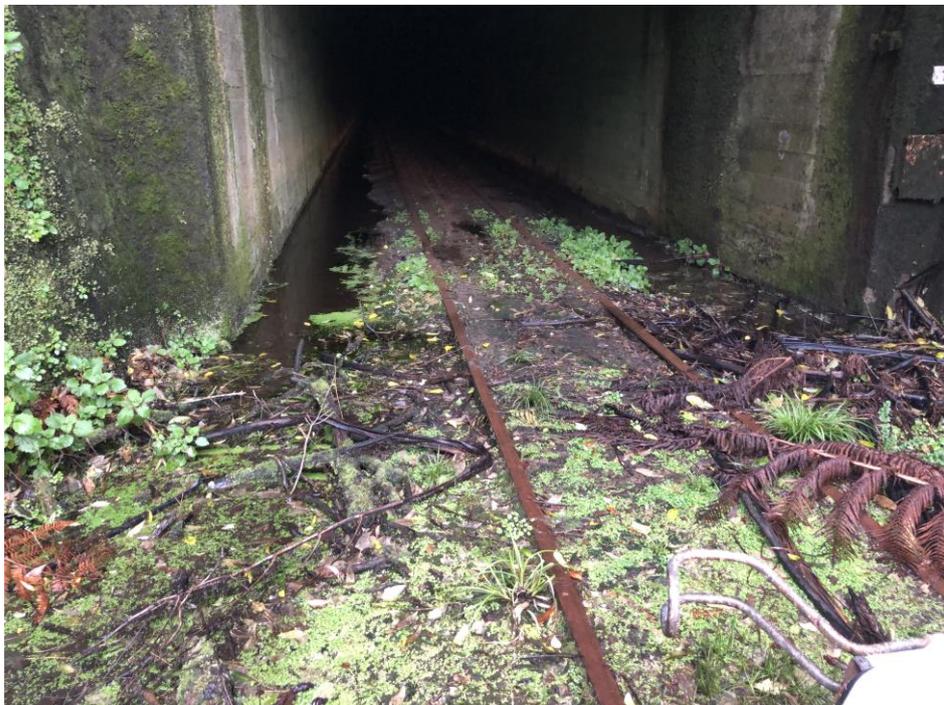
Everywhere the track is not on an embankment (fill) the track requires side drains at the base of the ballast shoulder. For large sections of this track these drains are in poor condition. Many have become choked with weeds, silt, slip material and displaced ballast shoulders. A team consisting of a hirail excavator and a hirail tip truck (Komatsu CD60 or Hydrema 912) should be engaged to work in a face initially through the section 345.0km to 360km where the worst issues are. After this area is addressed these resources should be directed to treat the remaining sites at either end of this section of line. Additional funds have been allocated for several of the larger slips (listed in the reopening spread sheet). The dump truck is advocated so that the drain cleanings can be disposed of in a tidy fashion in many instances to the advantage of the formation width (particularly rock / boulders). As mentioned above this exercise will also be the final cleanup of mulching debris and top of sleeper stripping's. The operators must be encouraged to leave tidy completed work at each site they address.

Figure 6 Blocked side drain at Portal

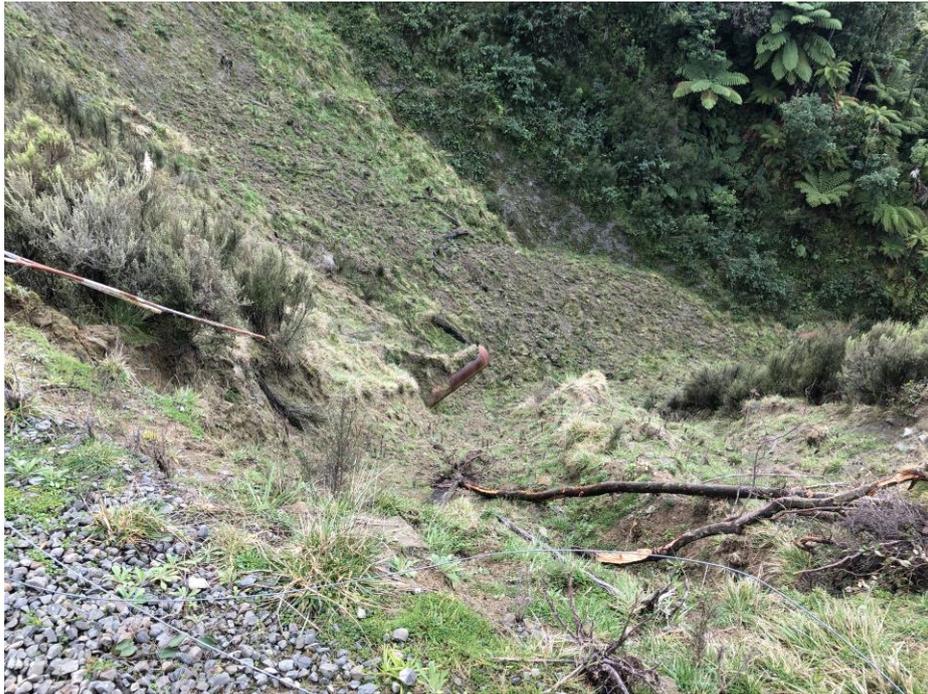
Drop Out 1. This embankment at the 358.42km has been rebuilt, the track reinstalled with poor alignment. However, the RHS fill batter is steep; the face scoured out in places and a steel culvert outlet requires better detailing.

Figure 7 Downhill batter and culvert outlet

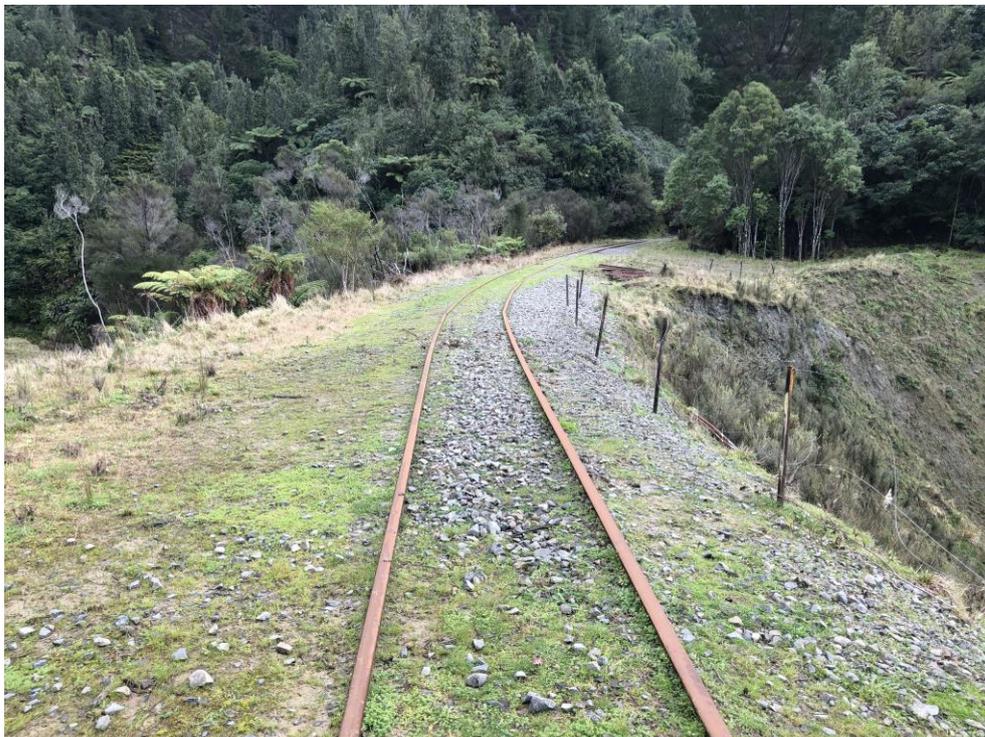
Figure 8 Drop Out 1 poor alignment

If this fill embankment is to remain unchanged the track traversing it requires adjusting to a more even horizontal alignment and further away from the edge of the RH batter. This curve also has had some Peruvian sleepers spotted in which will need replacing.

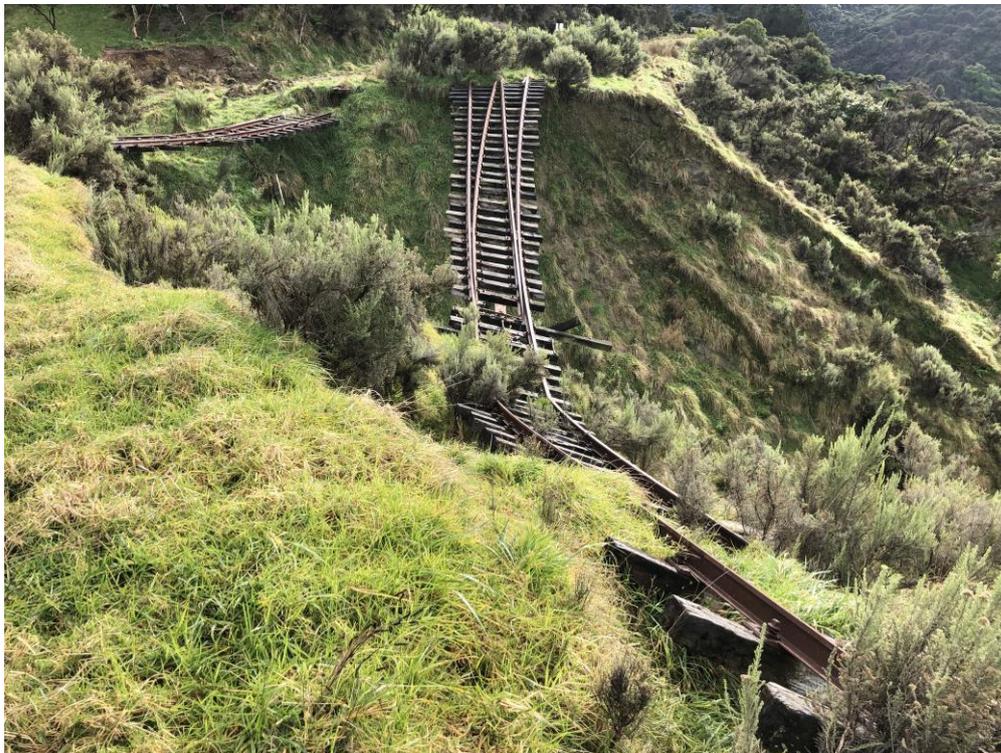
Drop Out 2. This site is situated at the 357.14km at the south end points for Beach Loop. The drop out has undermined the South end points 1A and also the back shunt. At the start of any repair work every effort should be made to recover as much undamaged track as possible from this turnout and backshunt. Beach Loop is considered a vital asset to reinstate for train operations and as a staging point for future maintenance and repair activities (i.e. crossing or run around of trains, stabling of tamper group etc.). It is intended to refurbish these components for reinstalling in the same location once the formation and culverting is reinstated.

Figure 9 Drop Out 2. Turnout to recover

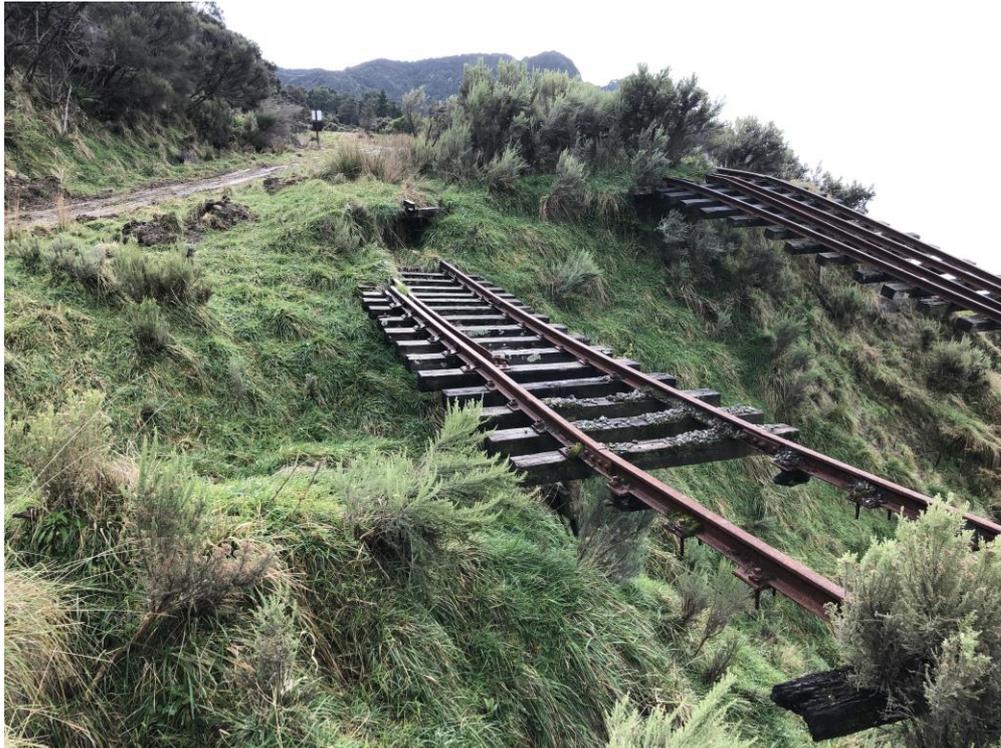
Figure 10 Drop Out 2 Backshunt

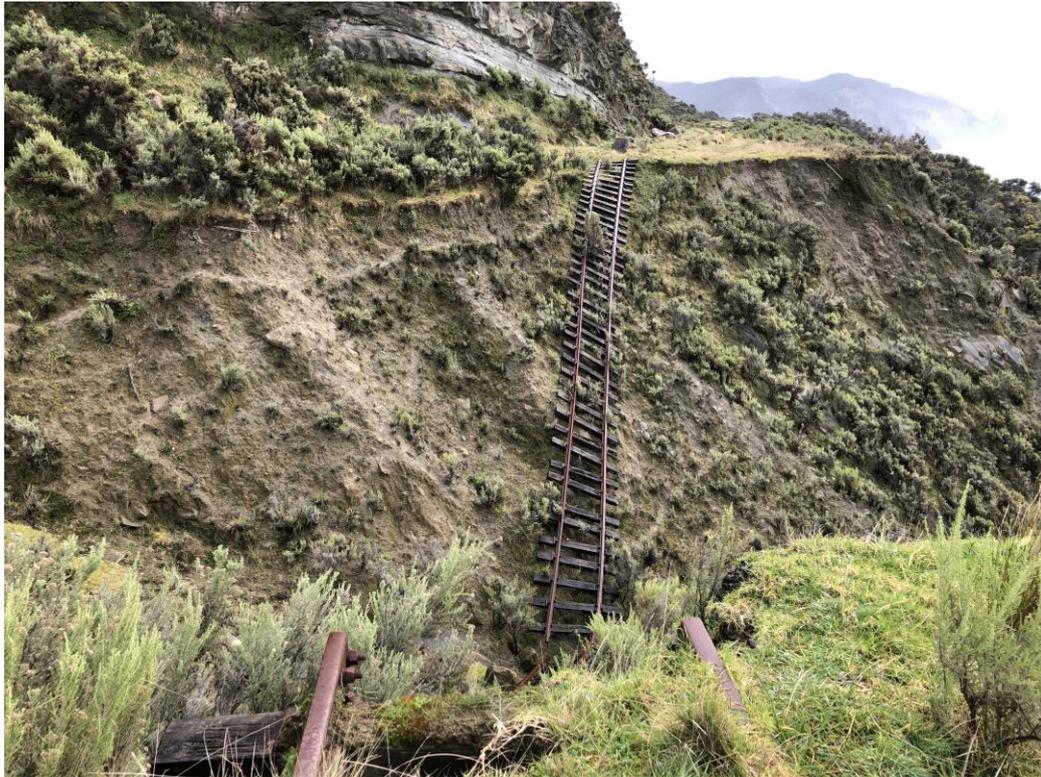
Drop Out 3. At this location 355.55km the drop out has occurred in the middle of a 100m radius RH curve in 70lb track. First task will be to recover the collapsed track for future reuse. Currently it is possible to off-track and drive around the head of this drop out.

Figure 11 Drop Out 3 looking north

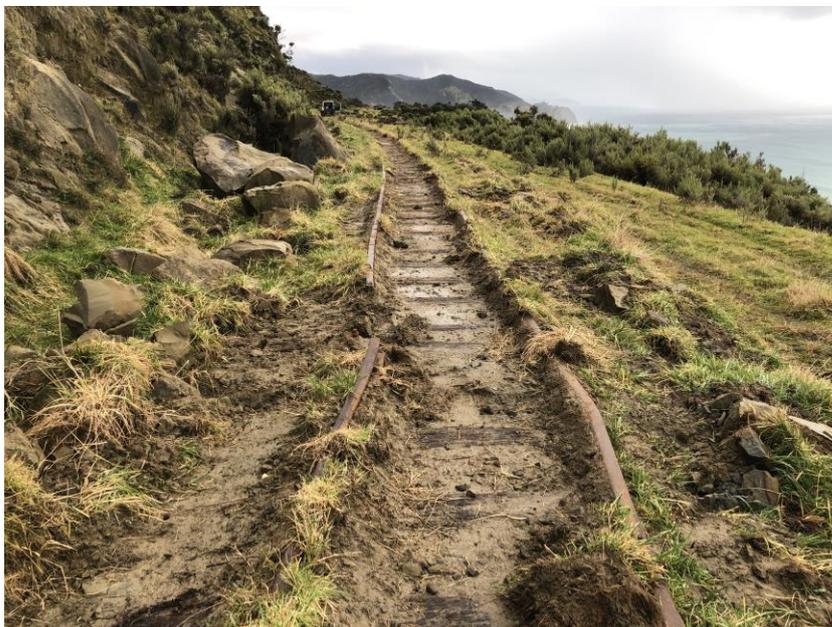
Figure 12 Rock damaged track

In addition, at this location to the north there has been rock fall damage and a sag in the track has developed due to large scale land movement. On this basis it is proposed to remove this entire section of track to allow access to address all of the formation issues. Then it is proposed to relay this entire length (430m) of 70lb track in new heavy weight rail and concrete sleepers (to join up with 91lb rail at either end)

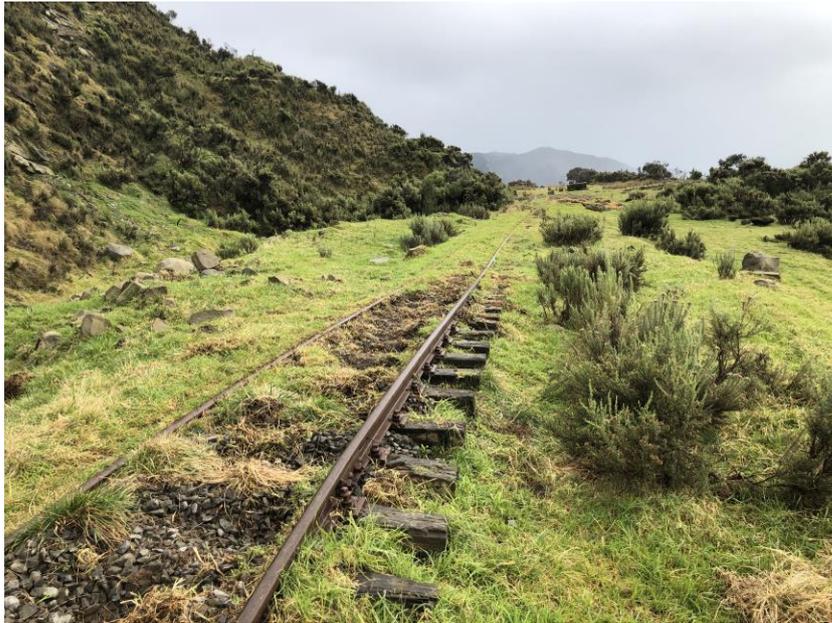
Figure 13 Area of sag

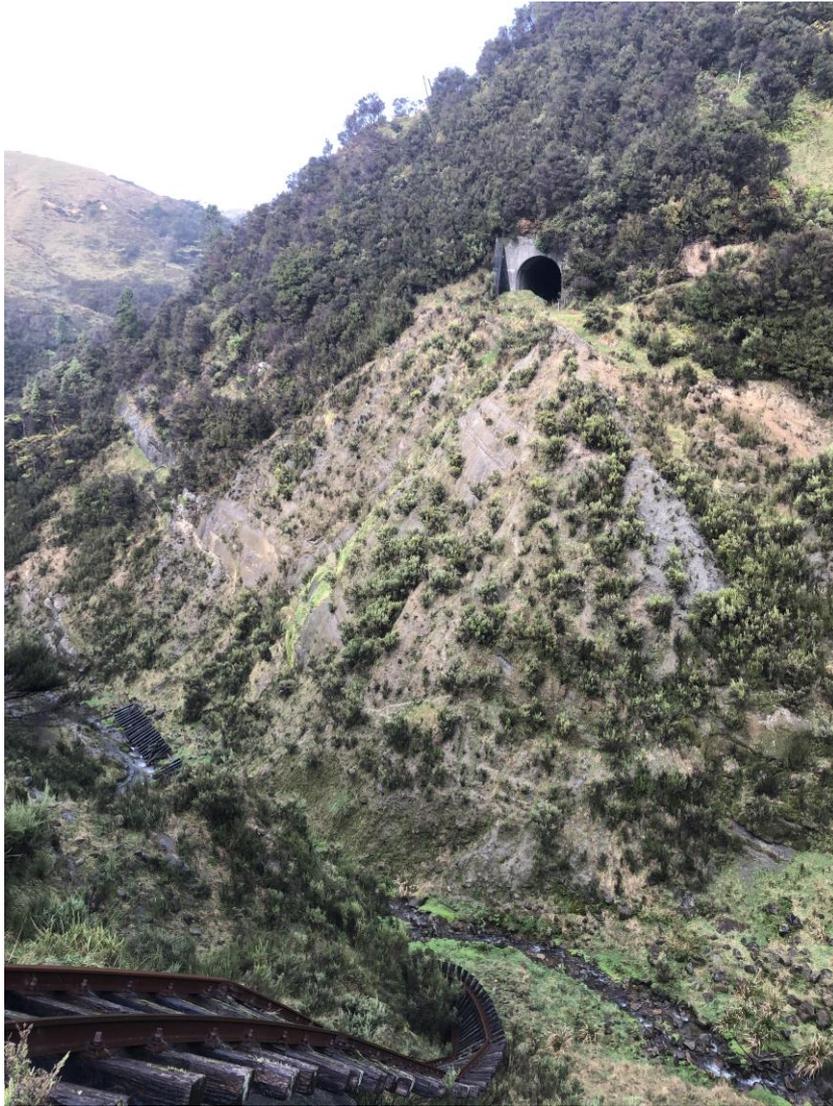
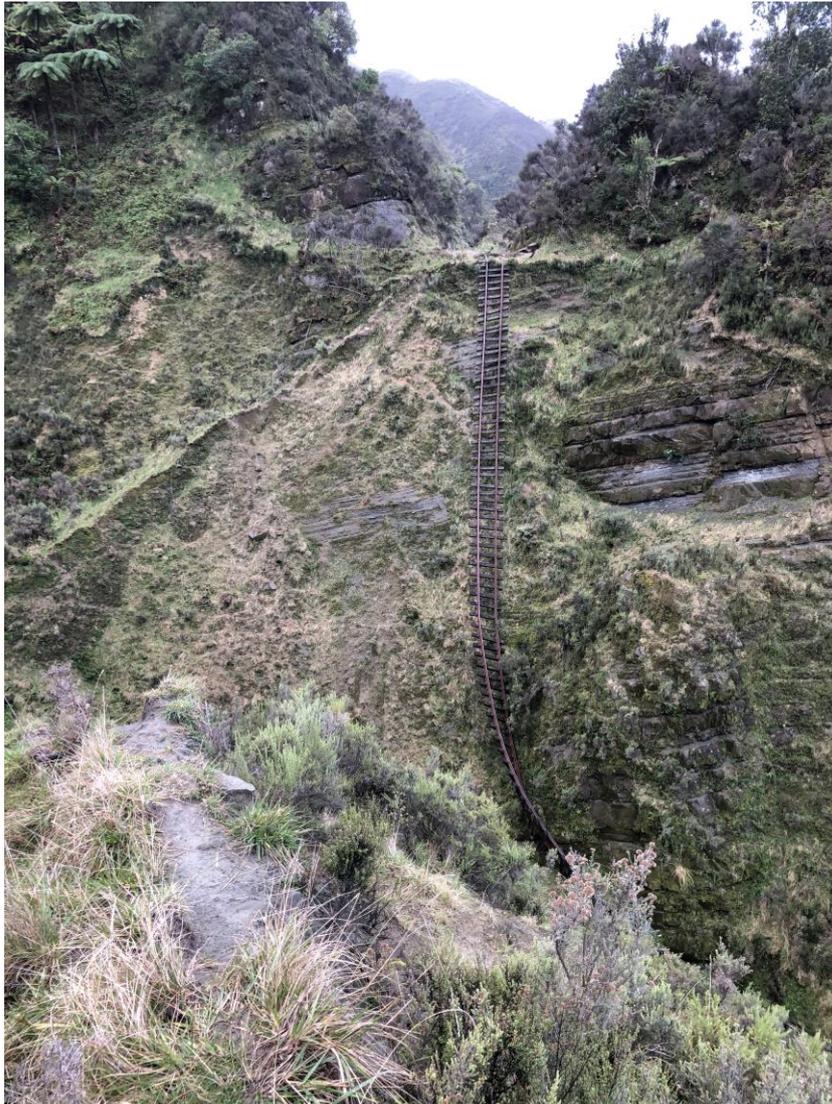
Drop Out 4. This is a significant failure at the 353.9km which has created the largest chasm that requires to be rebuilt and currently has severed all access through the area.

Figure 14 Drop Out 4. Looking south

Figure 15 Drop Out 4 looking north

Part of the earthworks will require the recovery of the strewn track down the north face and gully. This track is 91b rail on TPR sleepers with N fastenings and the majority may be reusable. Some materials may be recovered from track level and the remainder will need to be recovered from the gully floor once access for plant is created

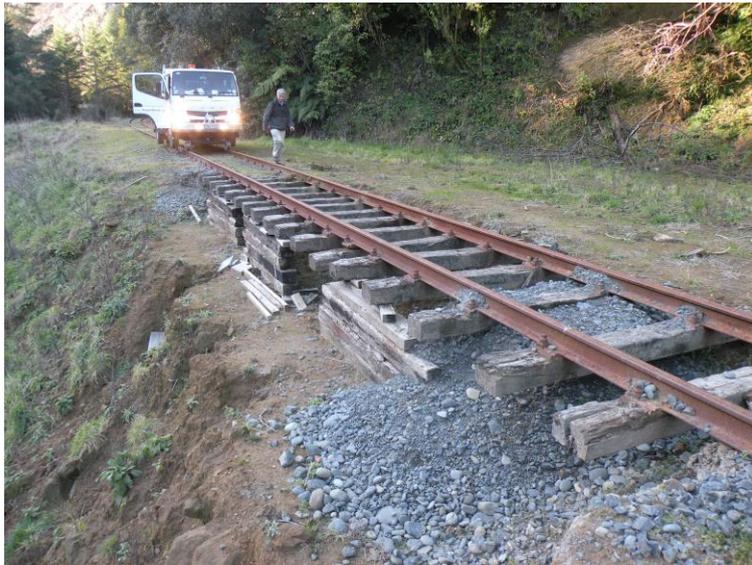
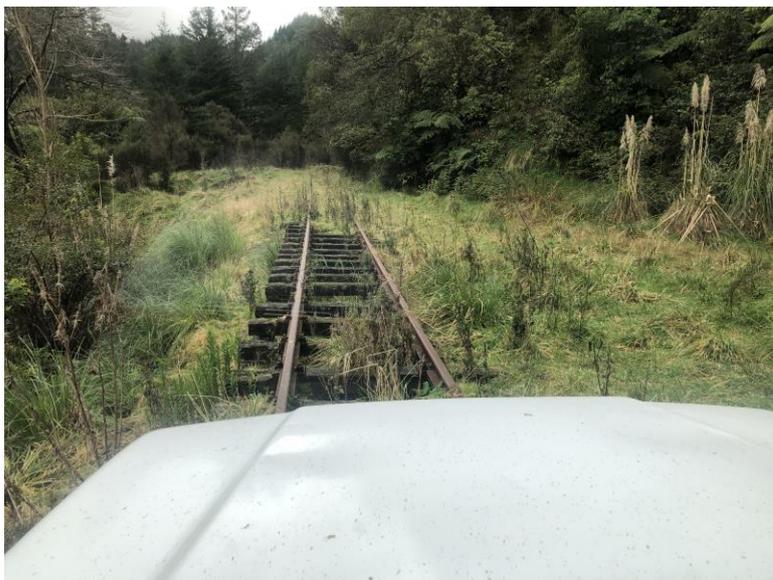
Dropout 5. At this location (348.8km) the track was left swinging when the LH batter collapsed towards the river. From the amount of retaining structures, rails scattered down the batter and old wagon bodies along the edge of the waterway there has been an historical problem in this area for some time.

The current failure has left 18 No sleepers hanging. This has subsequently been “pig styed” with other sleepers and wedges to allow the passage of lighter hirail vehicles (probably soon after the main rainfall event by local railway staff).

What is amazing is how this problem has been disguised by rampant weed growth.

Figure 16 Drop Out 5. As viewed in 2013

Figure 17 Drop Out 5. The same location as viewed 2019

To address this site it is proposed to cut the existing track into sets, and remove the timber supporting materials. This will then provide a clear work area for building of any retaining structures and reforming the formation up to ballast level. Once this is completed, and ballast spread, the original track would be reinstated.

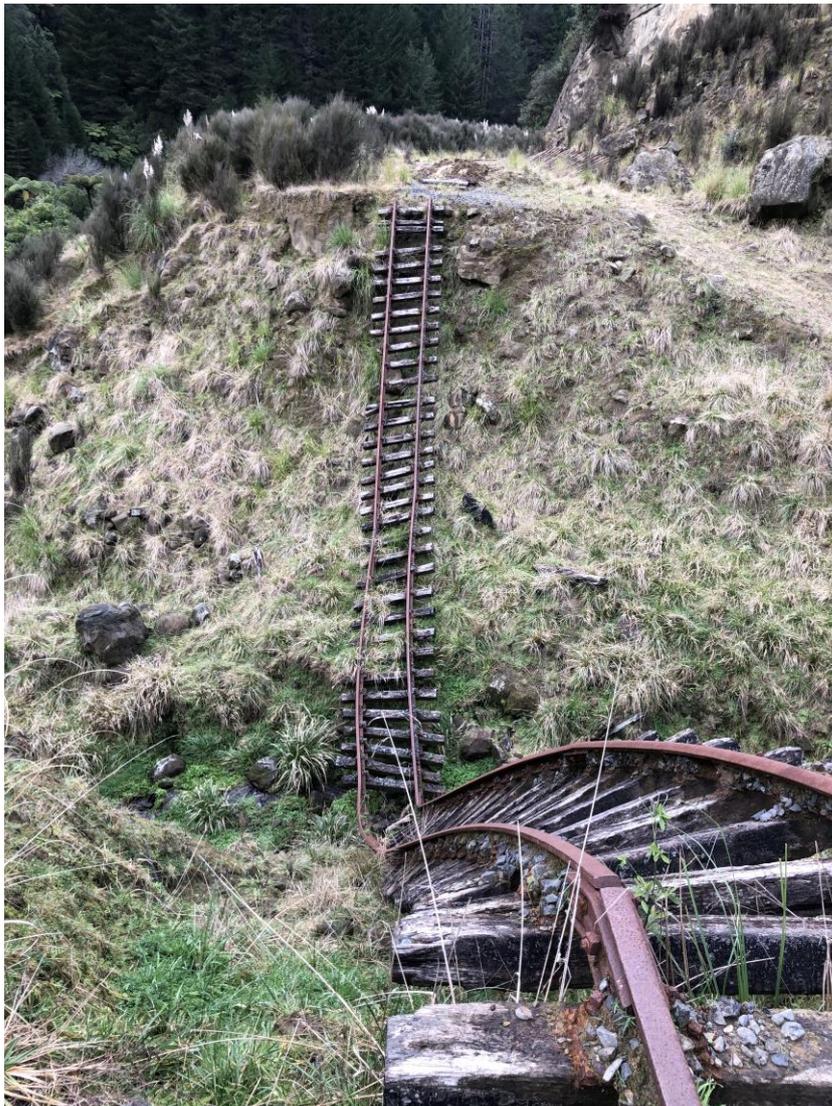
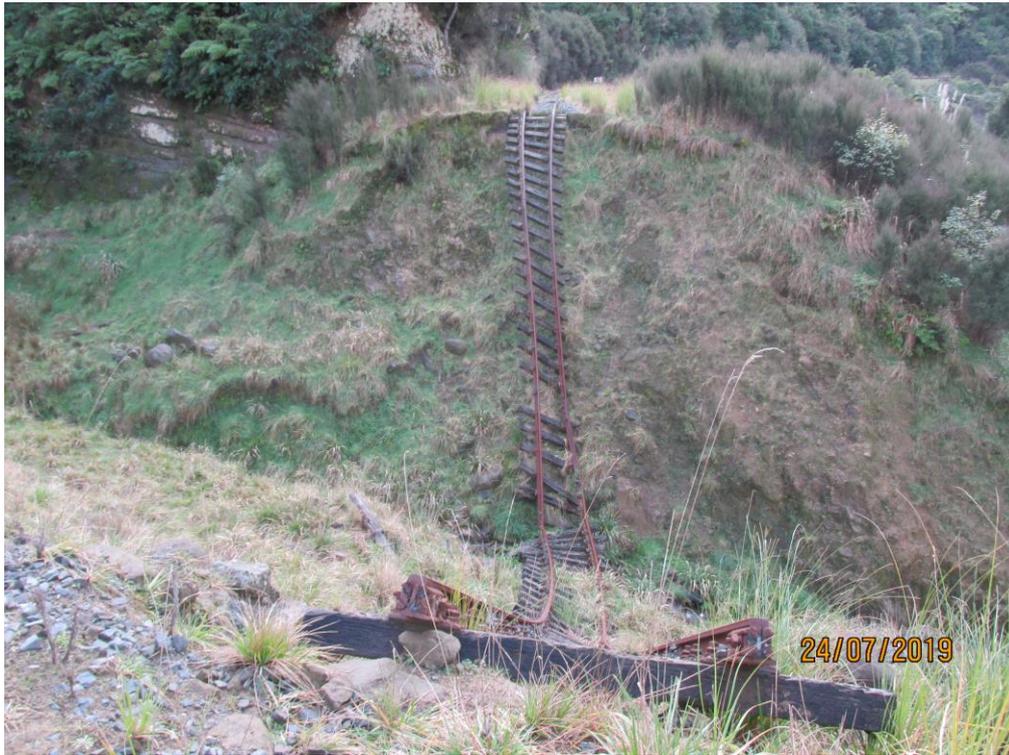
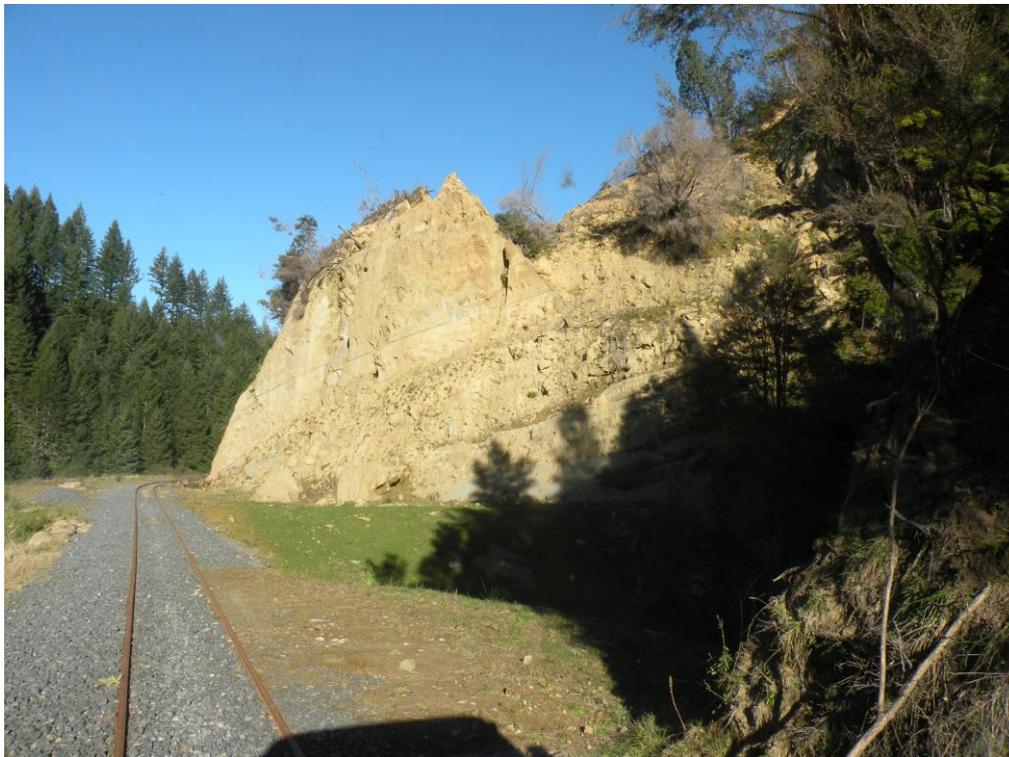
Drop Out 6. This site at the 347.3 km was a surprise as only when information from the 2013 visit was compared that it was appreciated that this failure has occurred in the intervening years since the line was mothballed . It is ironic that on the 2013 visit the bluff just to the south of this site was nominated as a possible quarry site for fill.

Figure 18 . Drop Out 6. Looking south

Figure 19. Drop Out 6. Viewed looking north

Figure 20 . Drop out 6. Looking south 2013

The existing track is 91lb rail on TPR sleepers and N type fastenings. Once the track formation and culverting is provided it is proposed to relay 60 meters of new rail on concrete sleepers.

The best parts of the old track should be recovered and reused

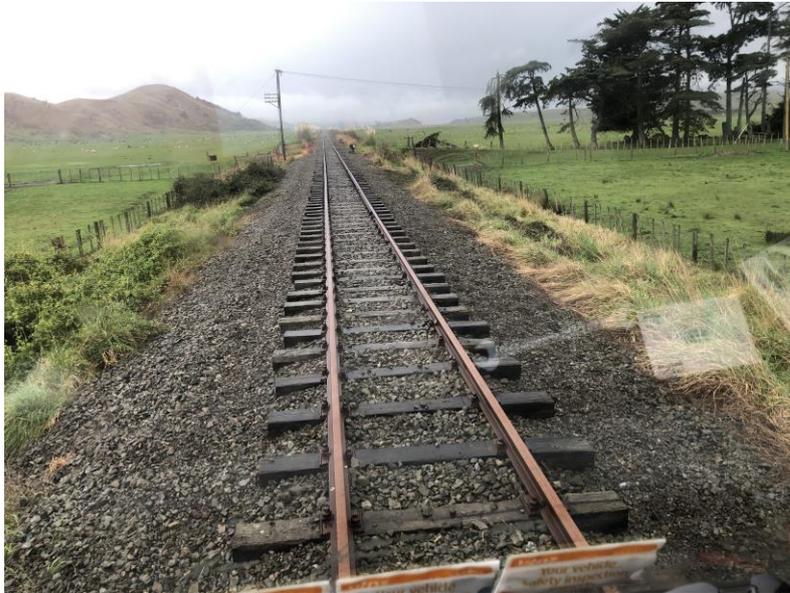
closure events. It has then been contaminated by slip material, poor drainage and rank weed growth. Currently the track is being abused further by neighbours/public using the rail corridor for access on 4 wheel bikes, road 4x4 vehicles and stock grazing (controlled by electric fencing or uncontrolled feral goats).

Figure 21 Damage by 4x4 bike and stock

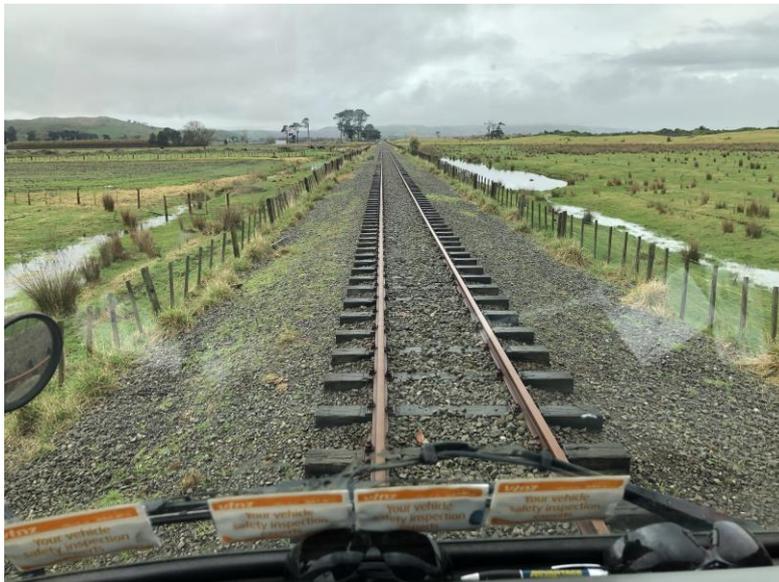
It is obvious this line had ballast shortfalls throughout its length prior to the line closure. Large sections of track have barely an adequate profile of ballast. Although most centre cribs are full to top of sleeper often shoulders are deficient or missing. In many instances the ballast profile has been compromised by poor or inadequate placement prior to the

Figure 22 Ballast section 320km

To address this situation it is recommended that a hirail excavator with a tilt head/wide smooth faced bucket should travel through the entire length attempting to pull up shoulder ballast. From this exercise deficiencies can be identified/prioritized then ballast purchased and imported by either truck or trains to stockpile in the Wairoa Nuhaka section or Matawhero (depending on where the supply is from). Ideally (to avoid double handling) this material will come from Otaki in ballast wagons and be discharged by work trains directly. If YJ wagons are used these can only be partially loaded to maintain the 16 tonne axle loading limit.

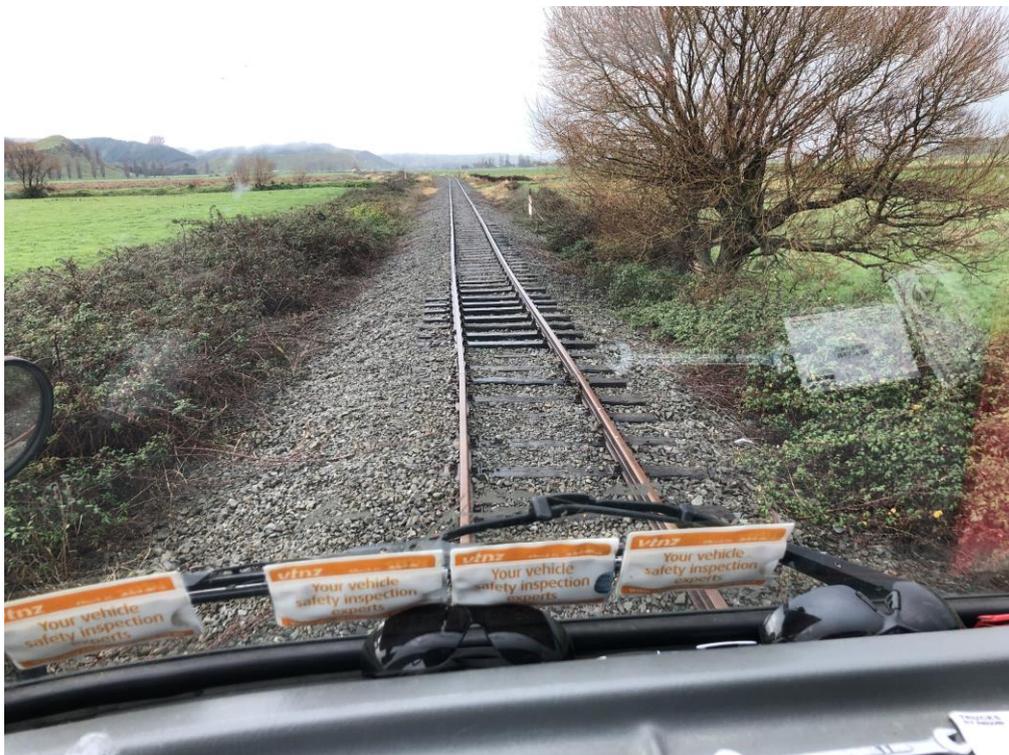
Figure 23 Misalignment related to ballast section

As part of this ballasting work a small team with a hirail excavator should attempt to line and box in some 25-30 minor misalignments in the track between Wairoa and the Paritu IB board. These faults appear to be heat related; possibly frozen fish plates, but primarily developed because of lack of ballast section. All of these can be negotiated at reduced speed if not addressed. (Virtually every joint was found to be open)

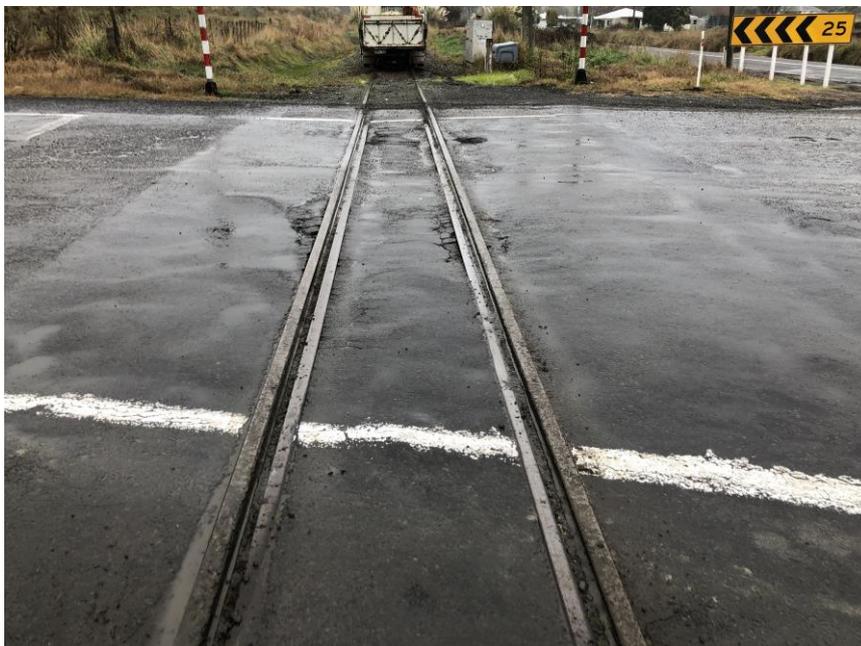
It is felt that this level of maintenance could be adopted for some years until rail traffic is significant. The first crossing to need up grading would be Te Uhi Road (SH2) at 296.75km. There is a suggestion that Awapuni Road at the 385.42 may be built on Peruvian sleepers but at this point there is no sign of any failure

Figure 24 Te Uhi Road (SH2) LX

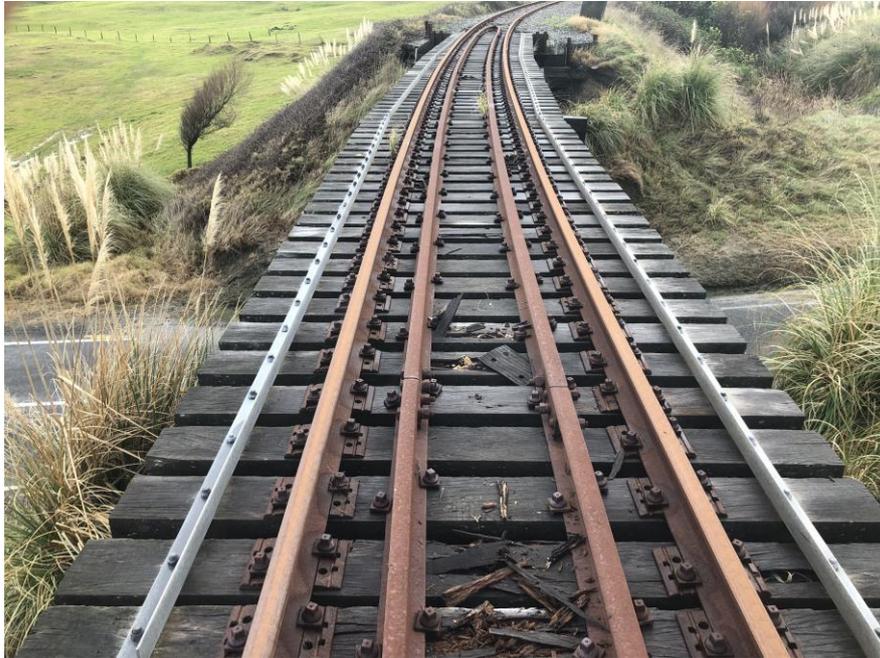
On this review we basically concur with the hardwood replacement but found the number of Peruvian requiring replacement had escalated to a further 132 No sleepers. It is recommended that all structures with

known Peruvian sleepers have a detailed inspection as looks can be deceptive. Some sites with tidy looking sleepers but when struck with an inspection pick were found to be very rotten.

Figure 26. Over Bridge 258 with failing Peruvian sleepers

The bridge resleepering to replace failed Peruvian sleepers will be a priority. These need to be addressed before any rail traffic (trains) can traverse many sections. This work is further complicated with the need to provide scaffolding for most structures and additional road protection for two over-bridges over SH 2.
