**WAIROA TO GISBORNE
INVESTMENT STUDY
DESKTOP REVIEW OF STRUCTURE
ASSETS**

Version No	Prepared (P) Reviewed (R) Amended (A)	Authorised for Release By	Date Effective
2.0	T Lewis (P) R Kotze (R)	J Skilton	15/10/2019

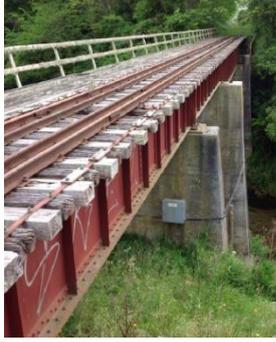
<p>PNLG Bridge 280</p>

- Bridge 280 has a water gauge fixed to it that is owned by Gisborne District Council, and they may require access to this. The gauge may require relocation once train services commence, as access to it will be restricted.
- Bridge 290 has a weather station on it that is owned by NIWA. This may require relocation once train services commence, as access to it will be restricted.
- Railbike Adventures Limited currently have a deed of lease to operate a rail venture between 295km and 385.3km on the line.
- Gisborne City Vintage Railway Incorporated have a tourism licence to occupy the line between 373km to 391.3km.

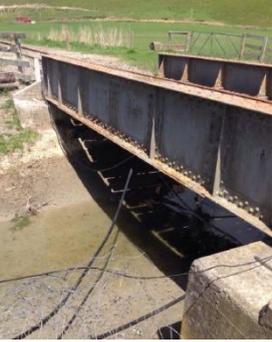
<p>PNLG Bridge 287</p>

Bridge 285			Pier 1 pile 3 restump	\$9,000	Blast and paint span	\$20,000
			Pier 1 pile 4 stump at 700 u/c	\$9,000		
			Pier 2 pile 3 stump at 800 u/c	\$9,000		
Bridge 286					Blast and paint spans	\$60,000
Bridge 287					Blast and paint span	\$20,000
